WHITE PAPER:

New Product Application: Restoration of Historic Masonry

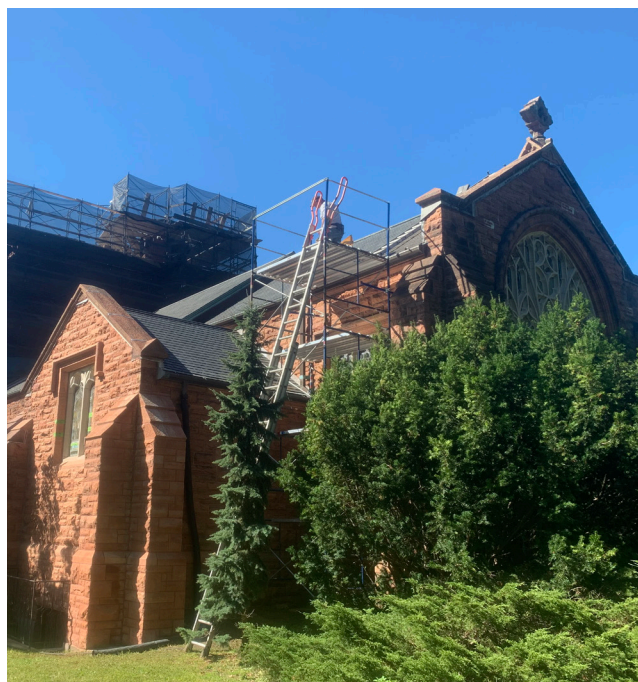
In 2019, Story Chapel, a historic structure in Cambridge, Massachusetts underwent a two-year exterior masonry repair project. Work included rebuilding many of the building's stone buttresses, and extensive repairs to the stonework on the upper portion of the chapel's tower.

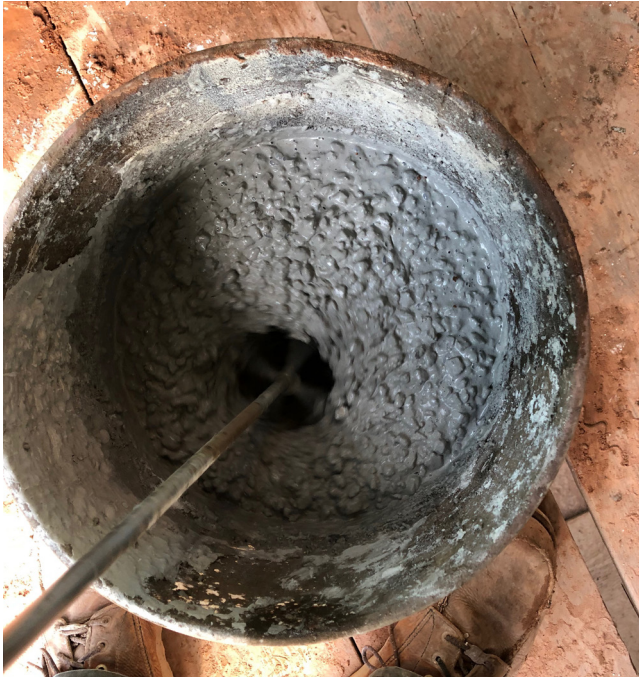
Professionals with Phoenix Bay State Construction of Boston utilized **EXTEND AGGREGATE** in the replacement mortar for Story Chapel. Here, the product is being mixed to a flowable, fluffy consistency prior to placement.

“The beauty of this product is that it can be blended on site with already mixed grout,” says Wathne. “By simply dumping the proper proportion of **EXTEND** into the grout pail and giving it a stir, the masons can turn a fine flowable PHLc Grout into a PHLc ‘concrete’ in as little time as it takes to mix it.”
